Repair of the lid on the heat storage

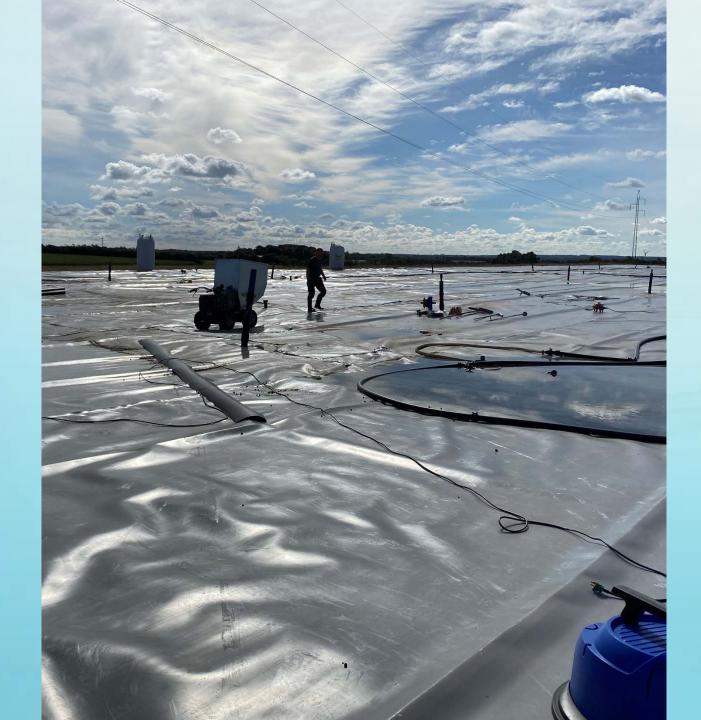
As it looked before.

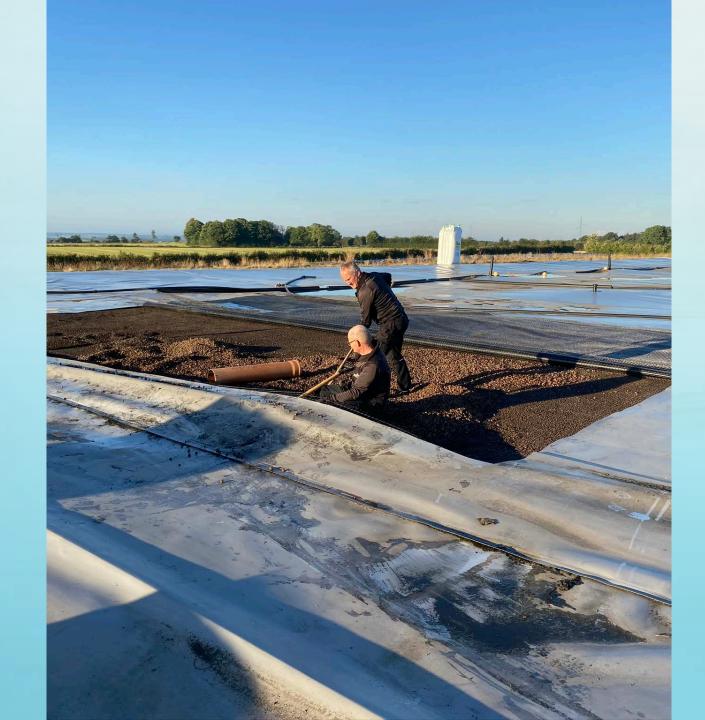
100 m³ Leca is refilled from 2.5 m³ bags

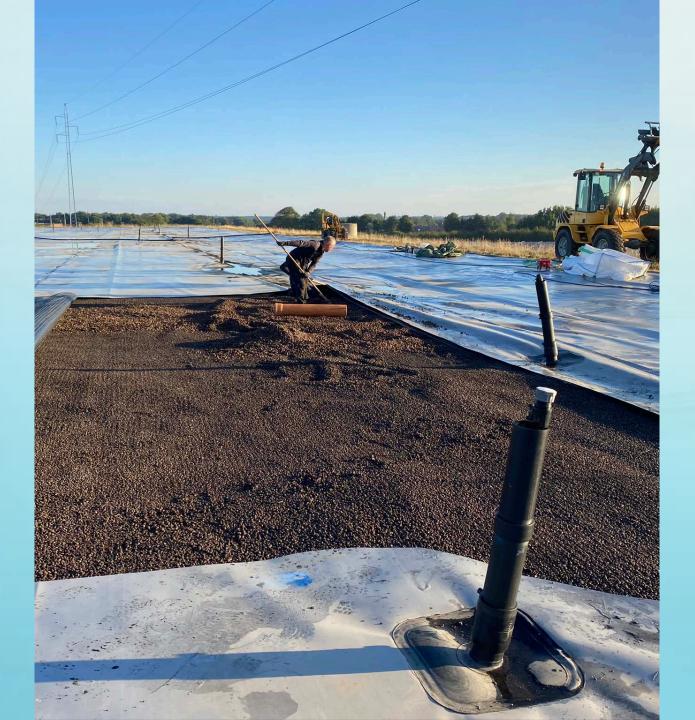
Filling a larger hole

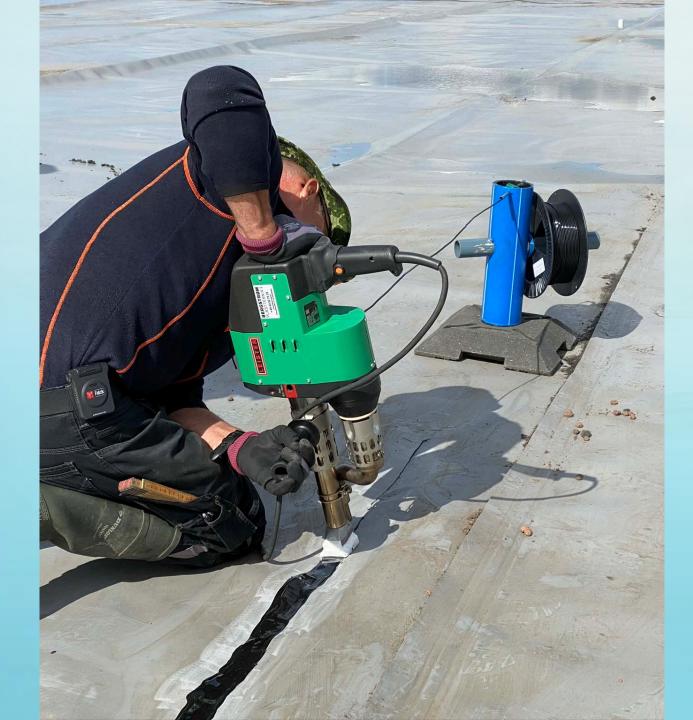
Filling a larger hole

There have been a number of air pockets that have been emptied of air.

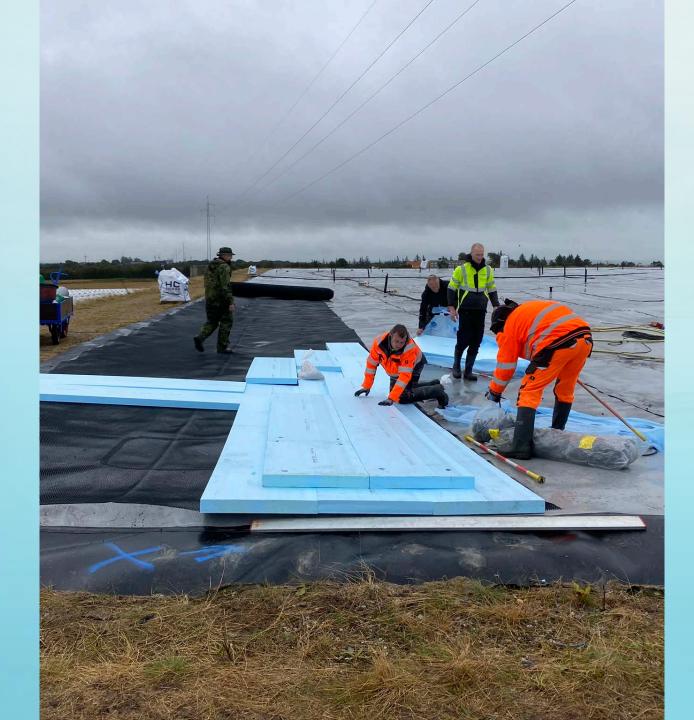
Welding of the old lid after filling Leca

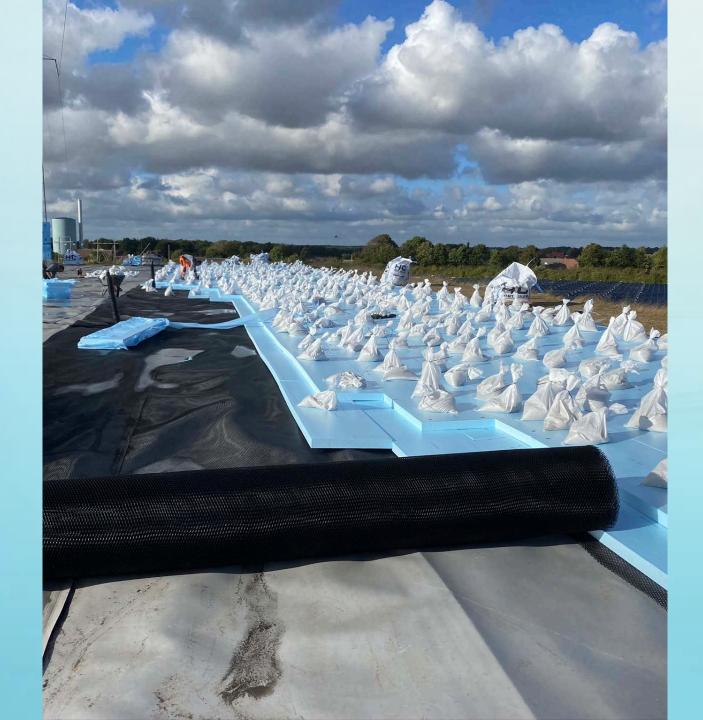
Plastic nails are cut in the upper insulation to hold the layers together.

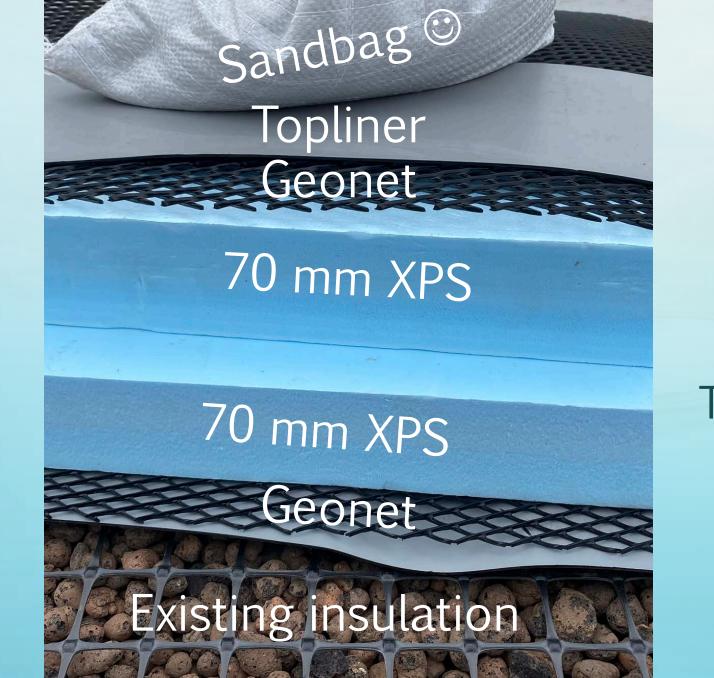
The sandbags move as you reach and weld the top cover

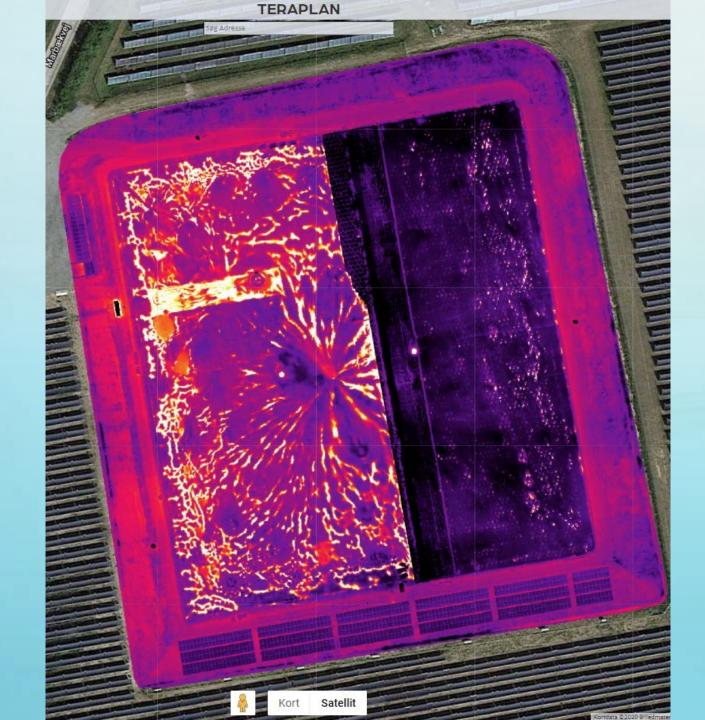
The new insulation
