Repair of the lid on the heat storage

2020

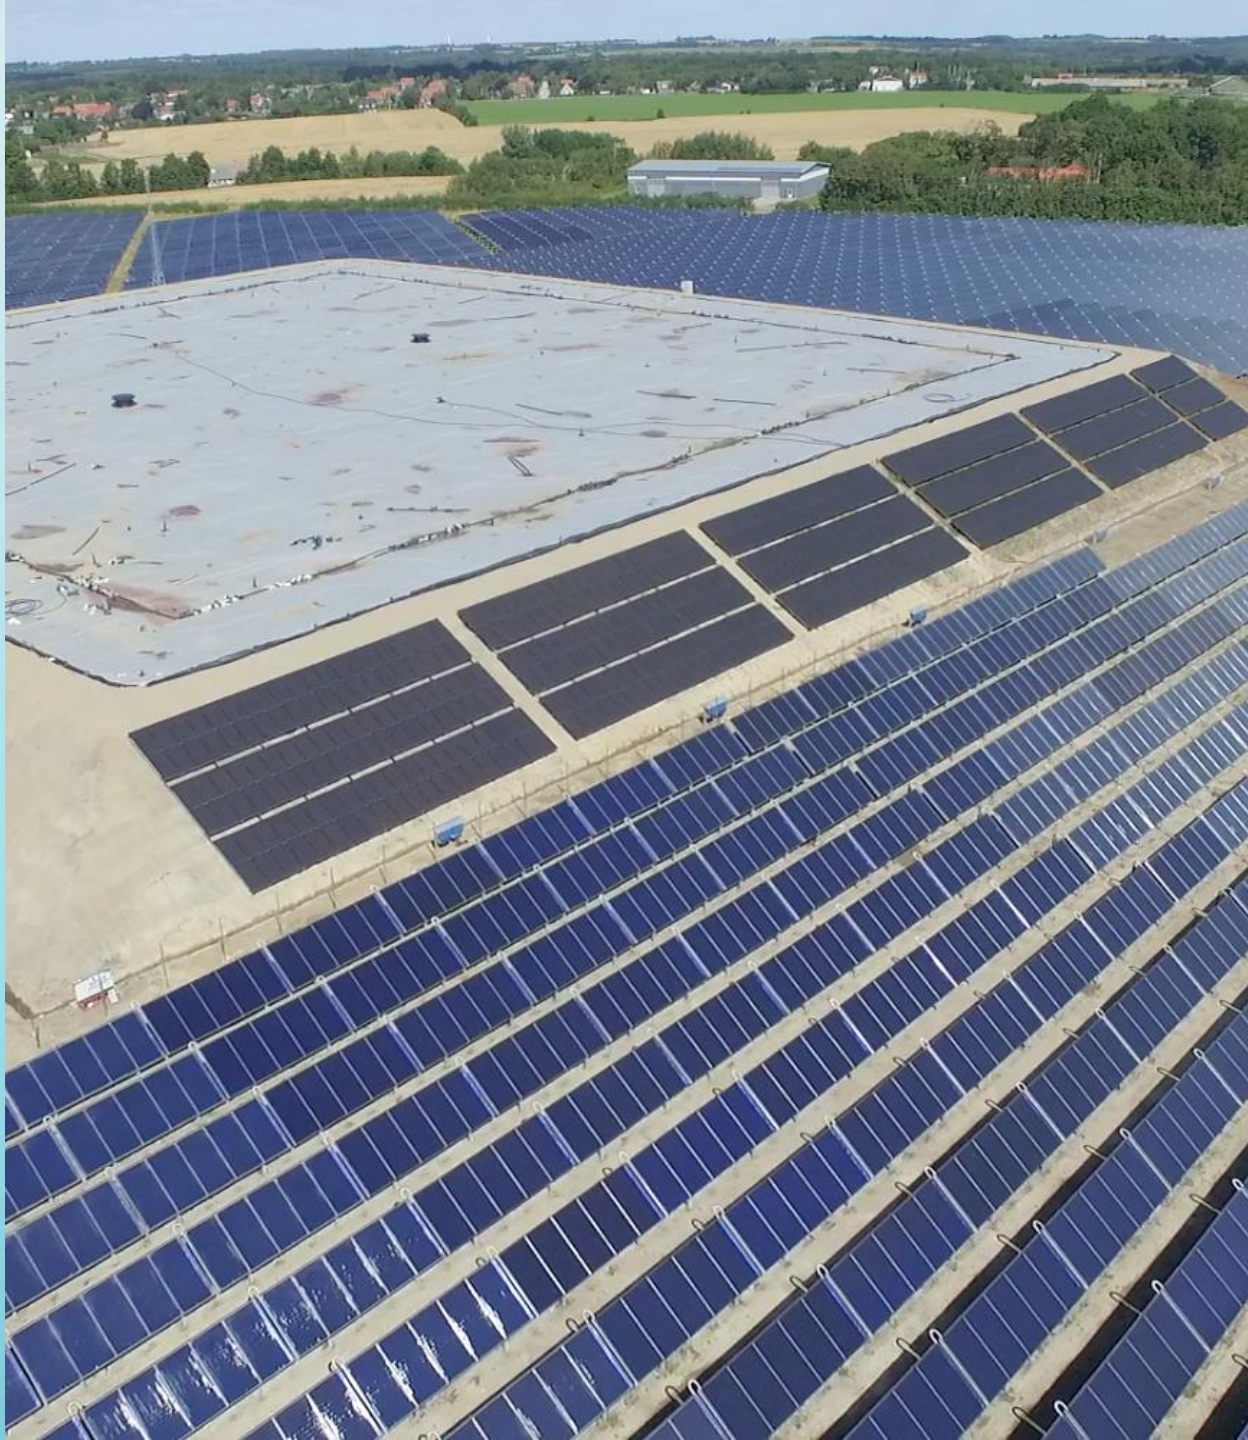
As it looked before.

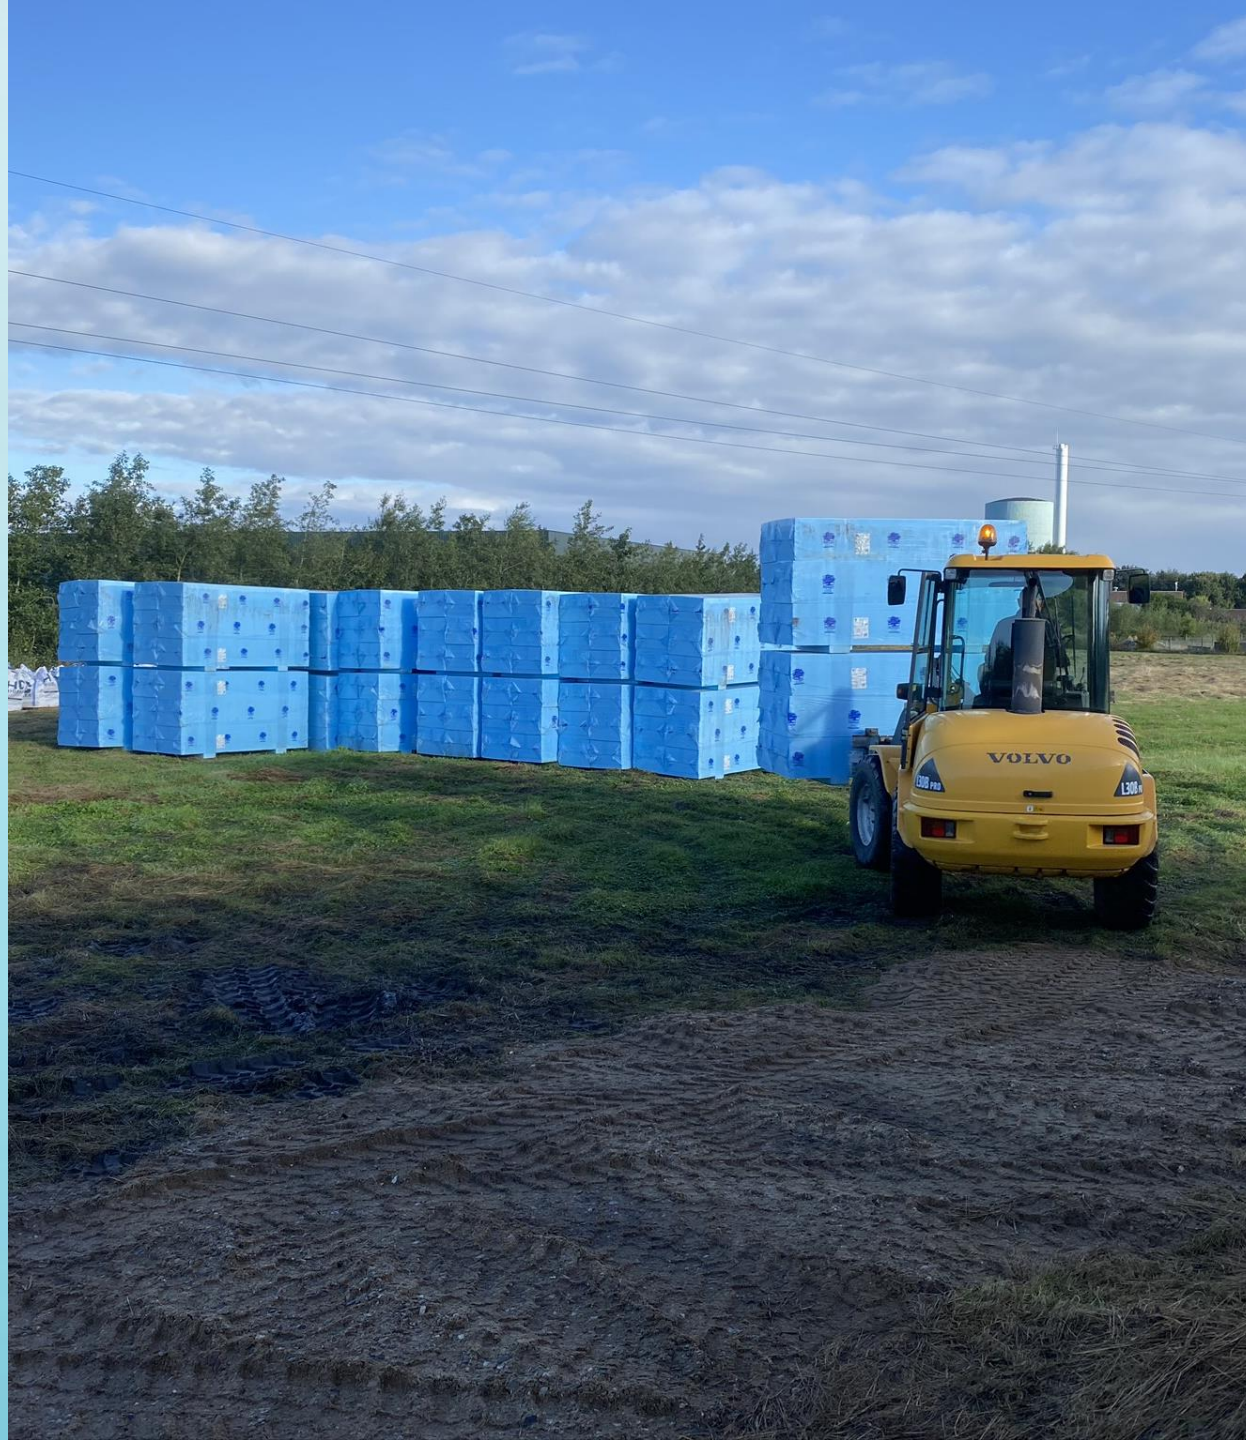
2x13.500 m² XPS
insulation arrives

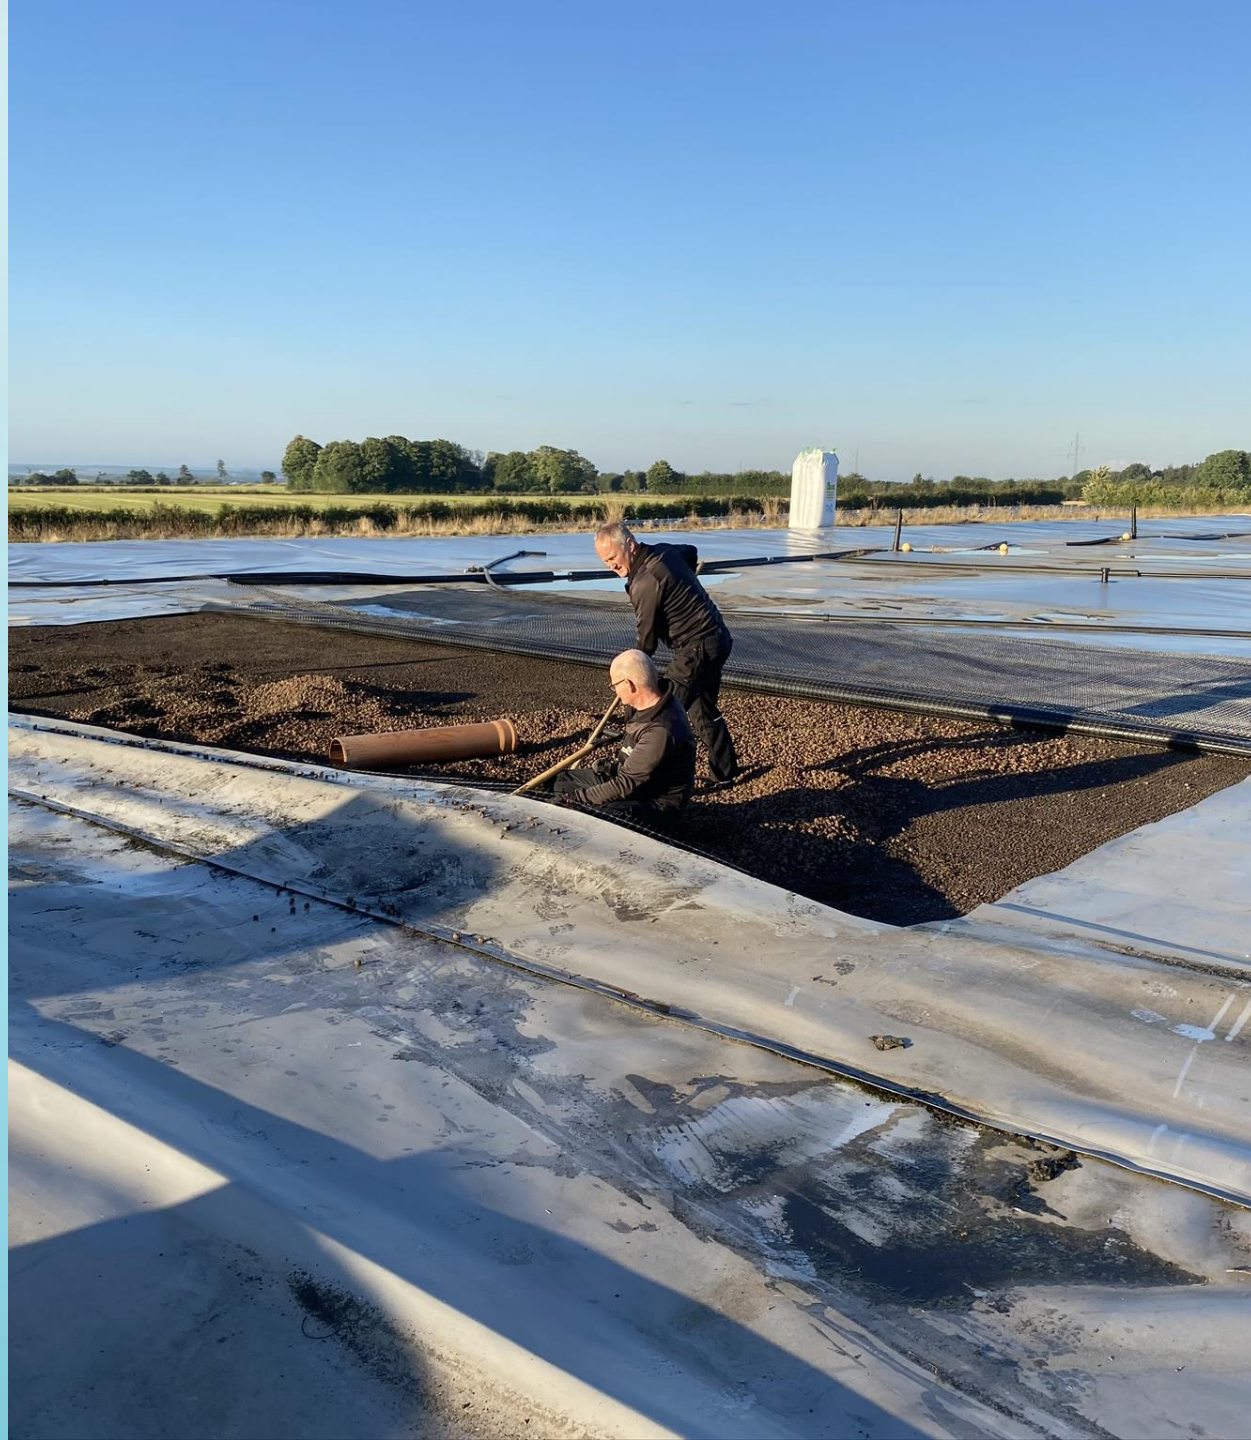
Filling a larger hole

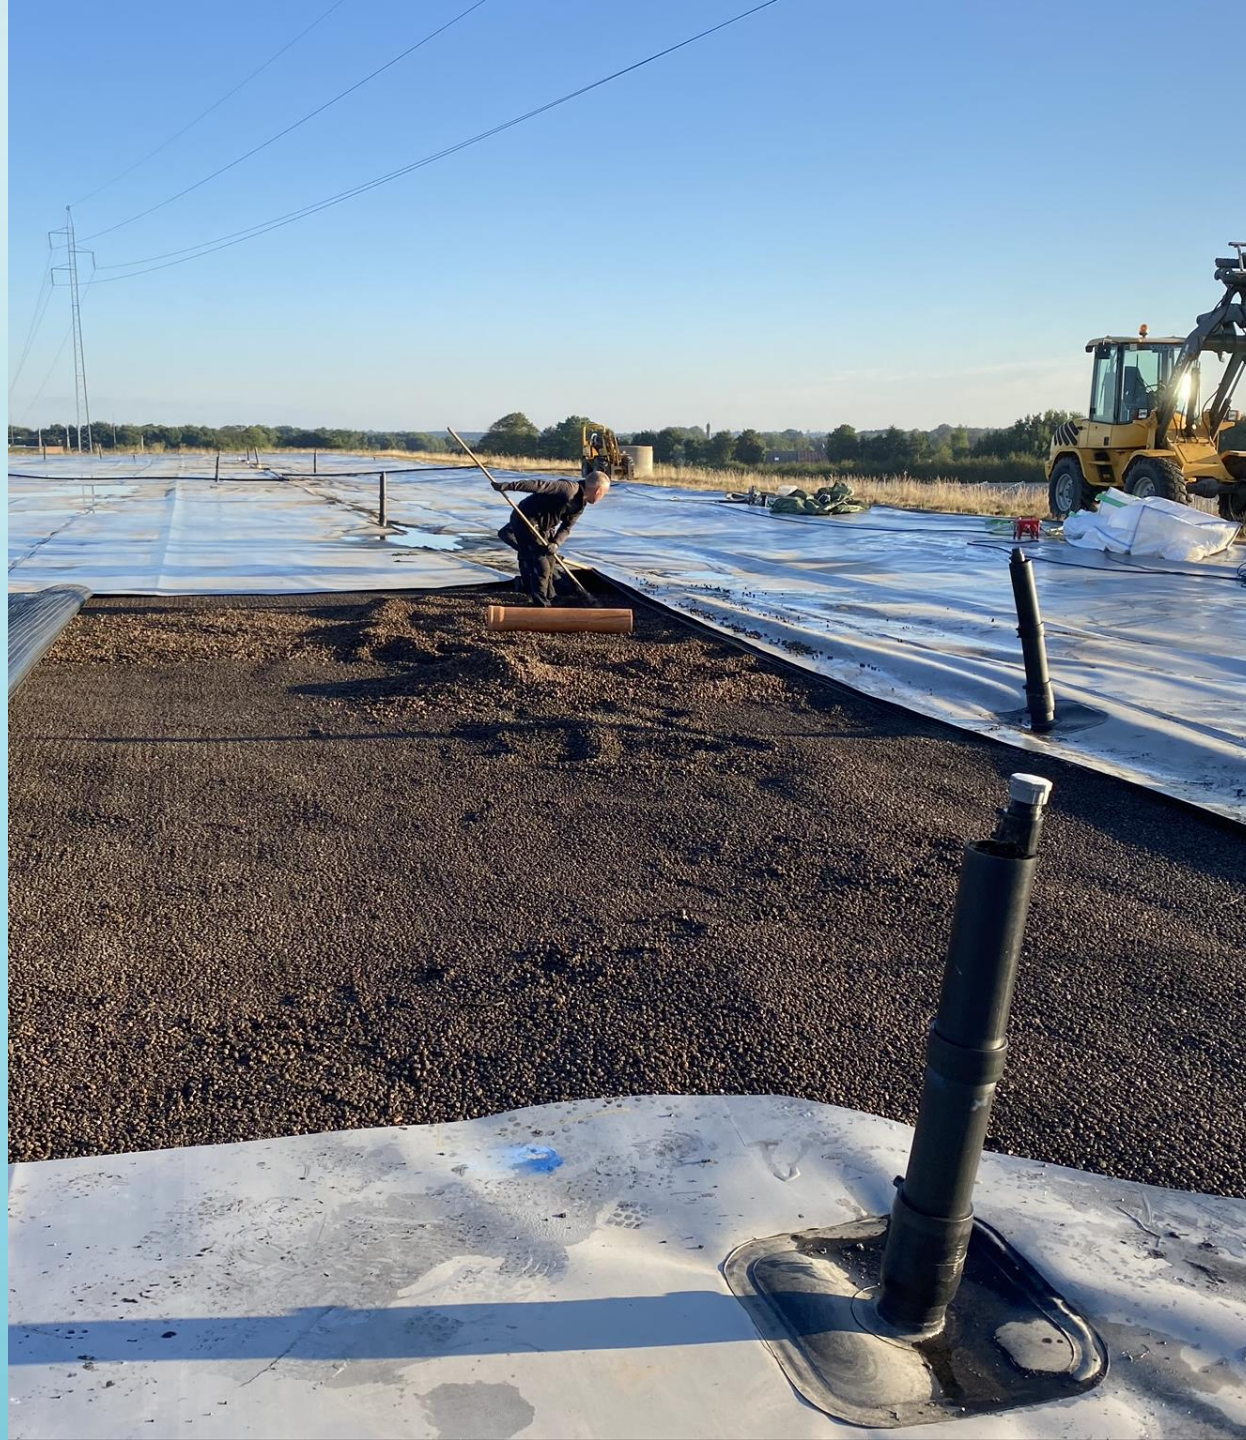
Filling a larger hole

There have been a number of air pockets that have been emptied of air.

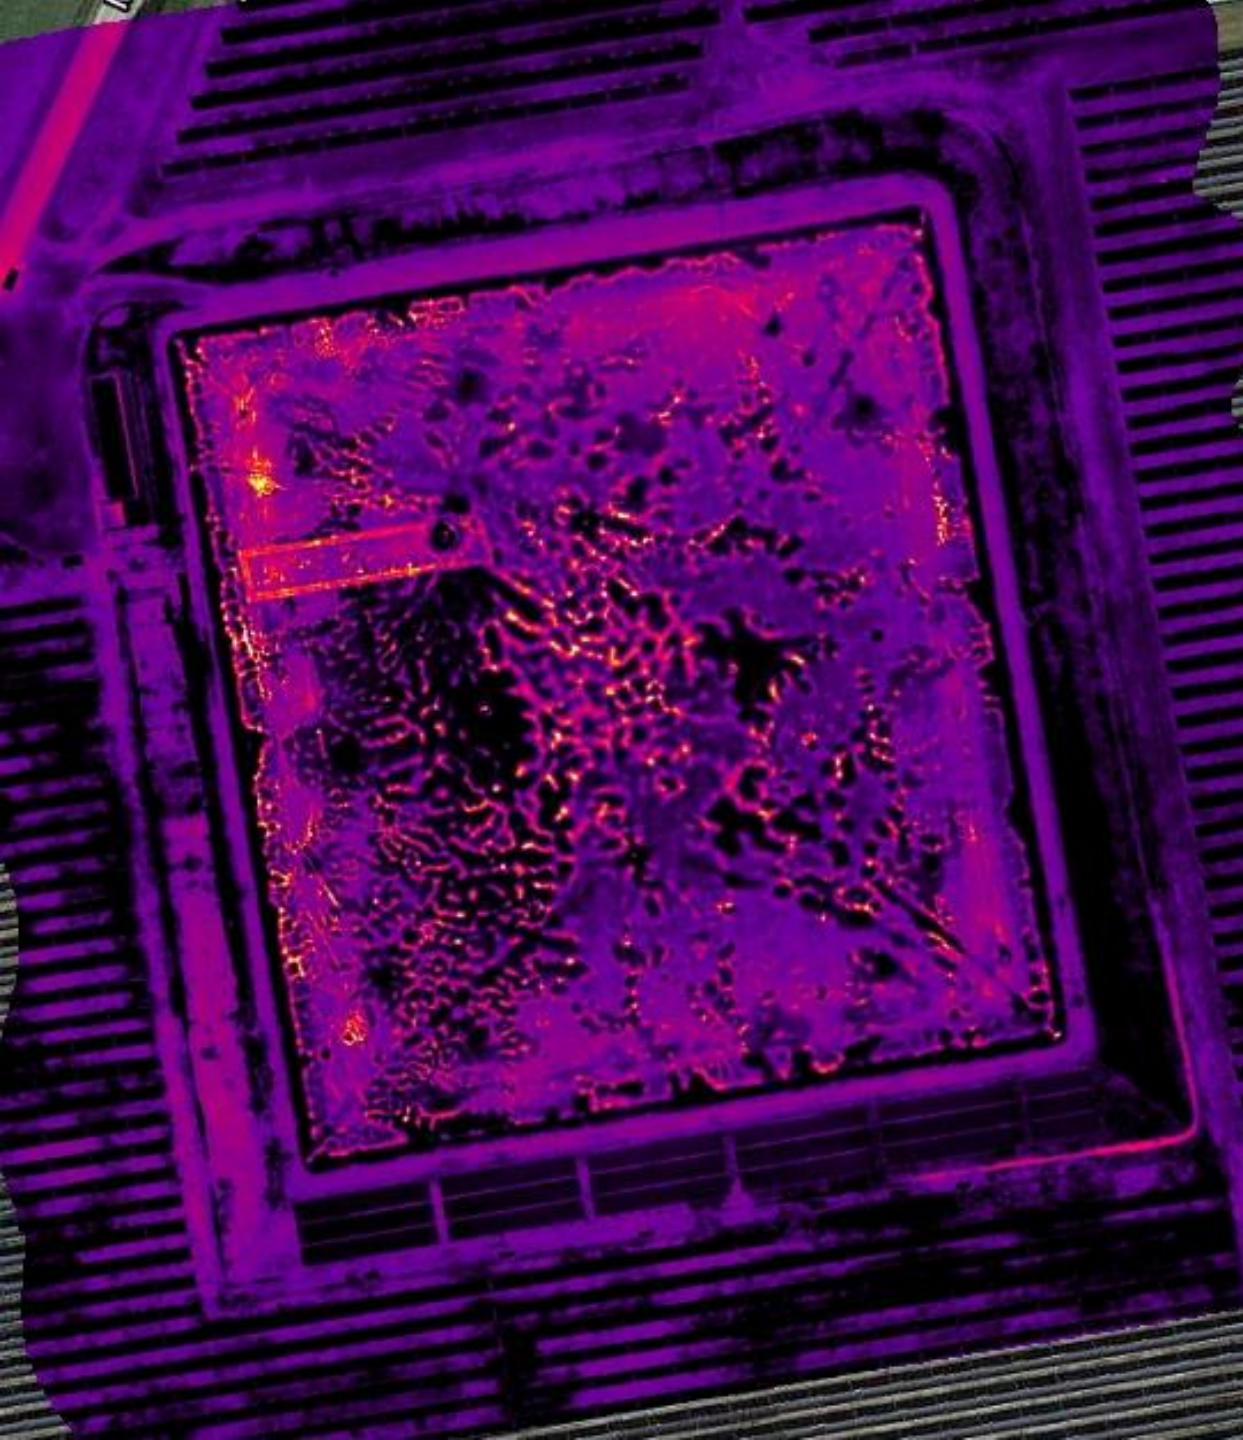
Thermal photo 1

The photo was taken on May 2019
before the after insolation.

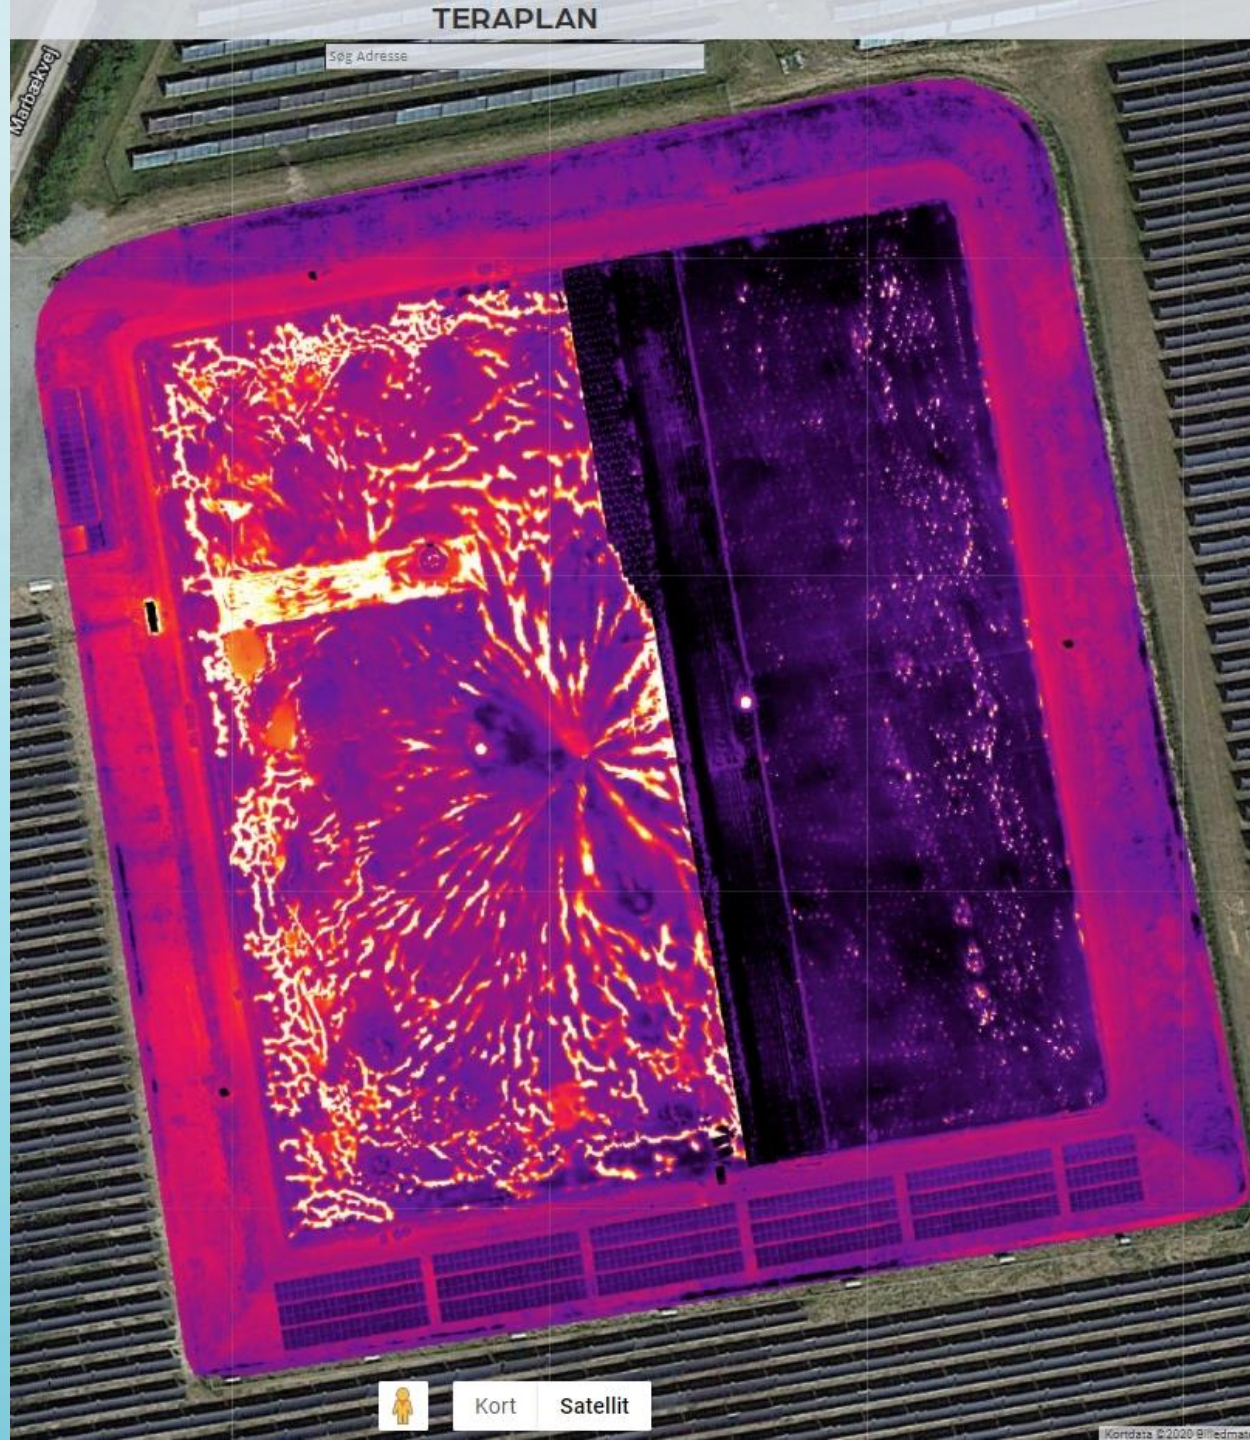
Thermal photo 2

The photo was taken on Sept. 23
early in the morning.

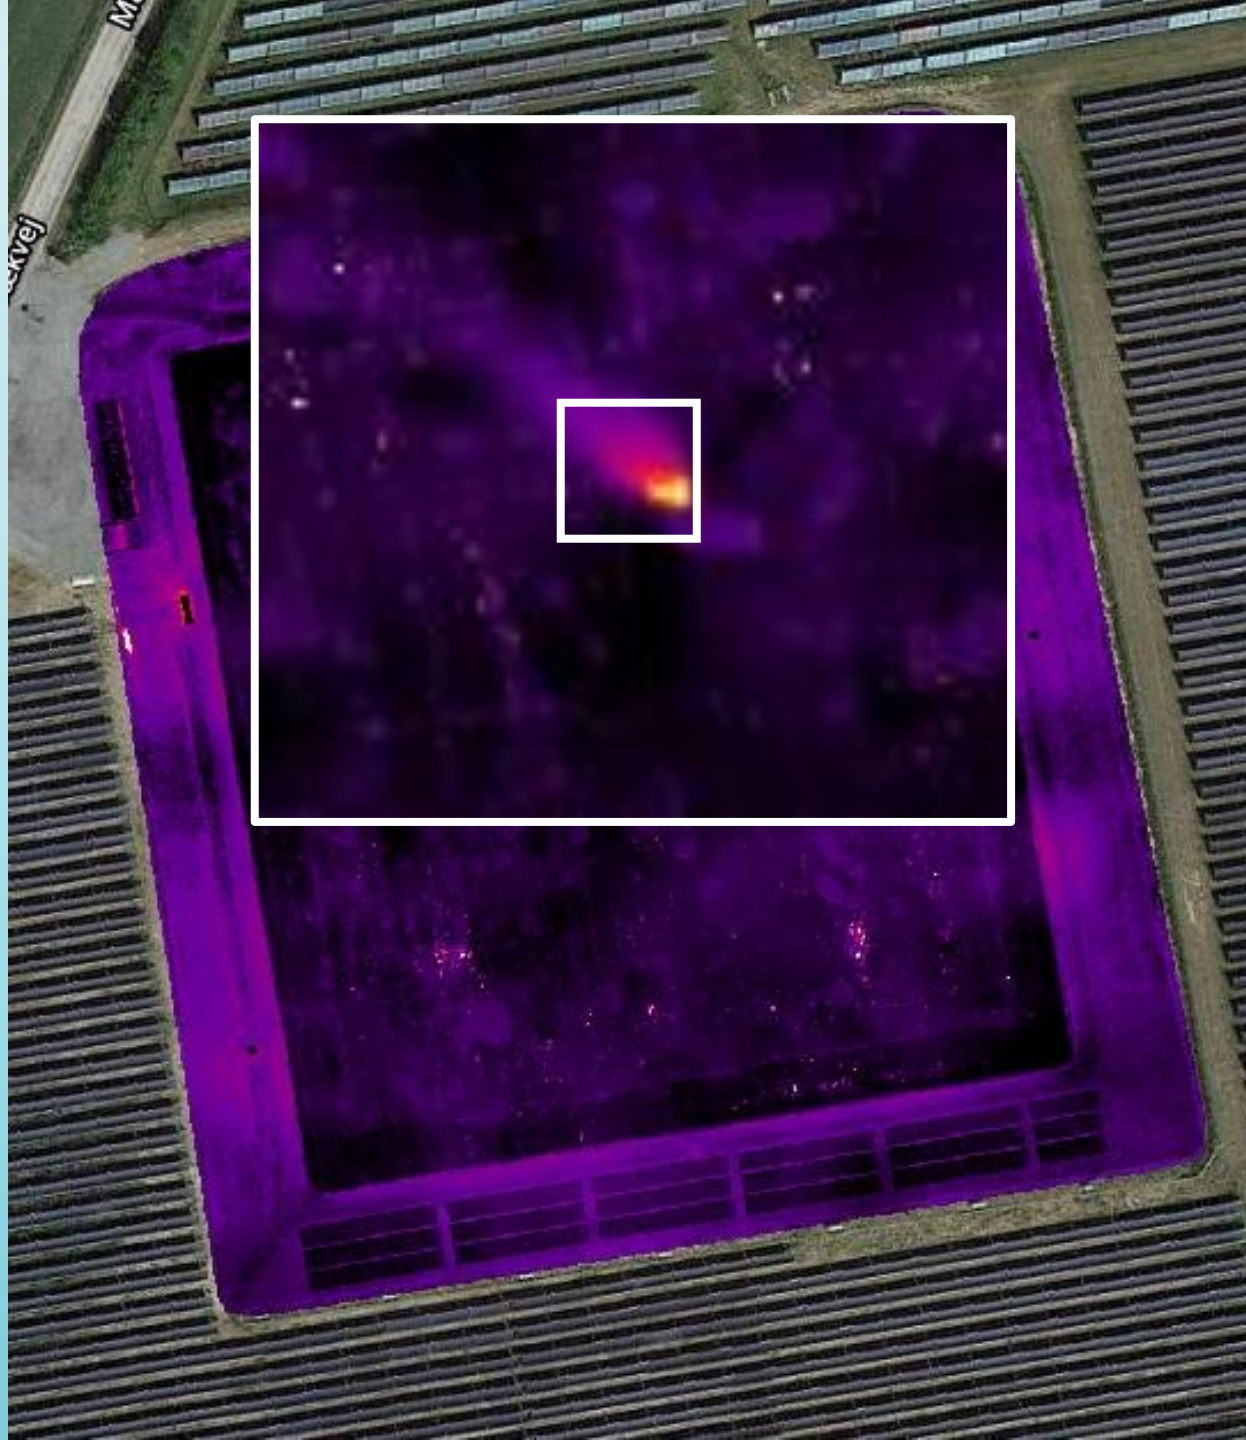
Thermal photo 3

The photo was taken on december 2020. The job is done.
